# INSPECTION AND RETIREMENT CRITERIA (SERVICE LIFE)

## **LANEX, a. s.**

# INSPECTION AND RETIREMENT CRITERIA

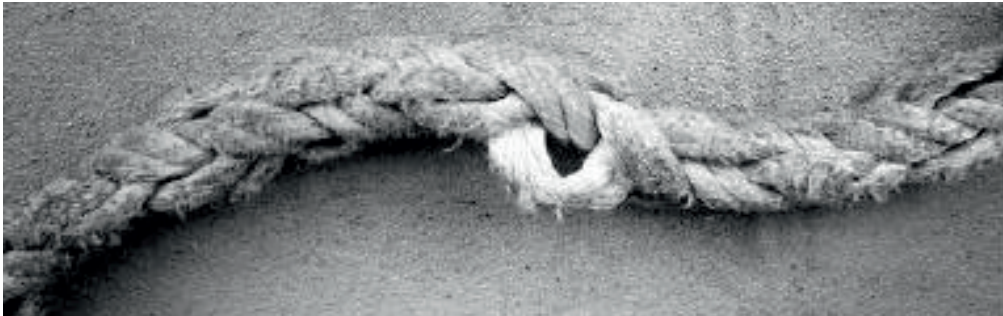
For twisted and 8-strand plaited ropes most of the wear will occur on the inside of the rope where the strands rub on each other. Broken, matted filaments and a powdery residue may be observed. Figure no. 5 shows how to expose the inside of the structure by pushing on the rope and possibly exposing one strand. For laid ropes, twist the rope in the opposite direction of the lay.

Figure no. 5: **Matted internal yarns (exposed stands reveal internal matting)**

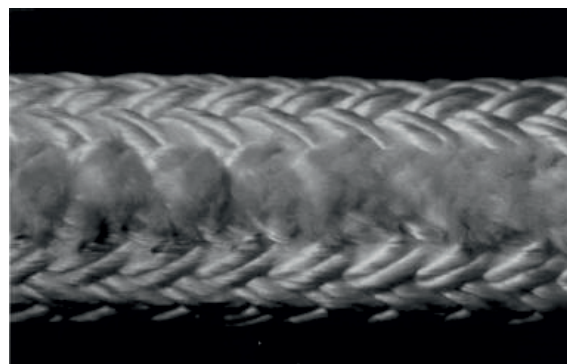
Figure no. 6 b): **External abrasion - Localized external abrasion 1**

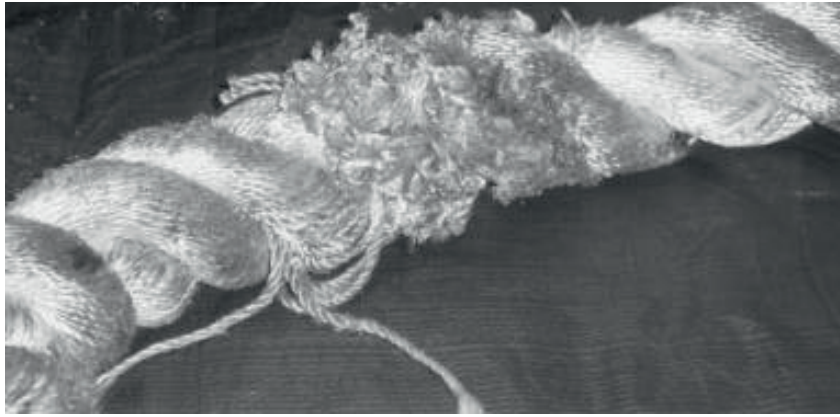
Figure no. 6 c): **External abrasion - Localized external abrasion 2**

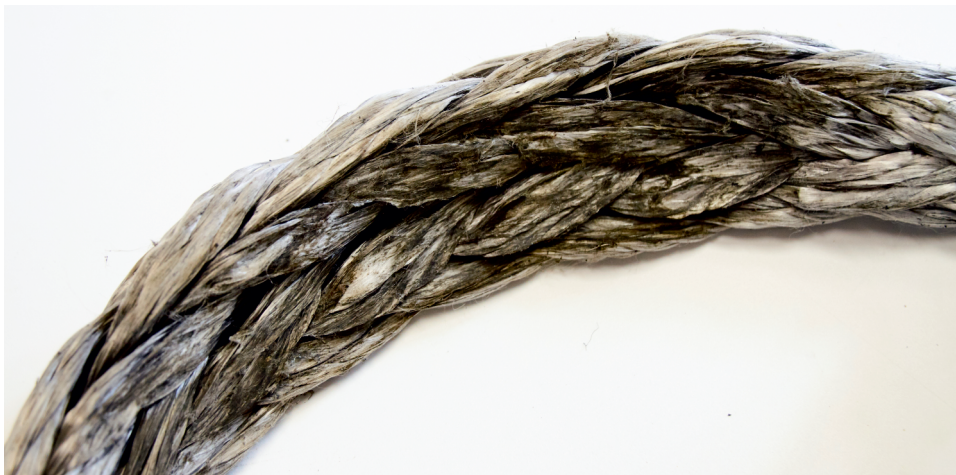
The surface of the rope may be melted and appear black due to sliding while bent over surfaces when under high tension (see figure no. 7).

Figure no. 7: **Burn and melting from external abrasion**

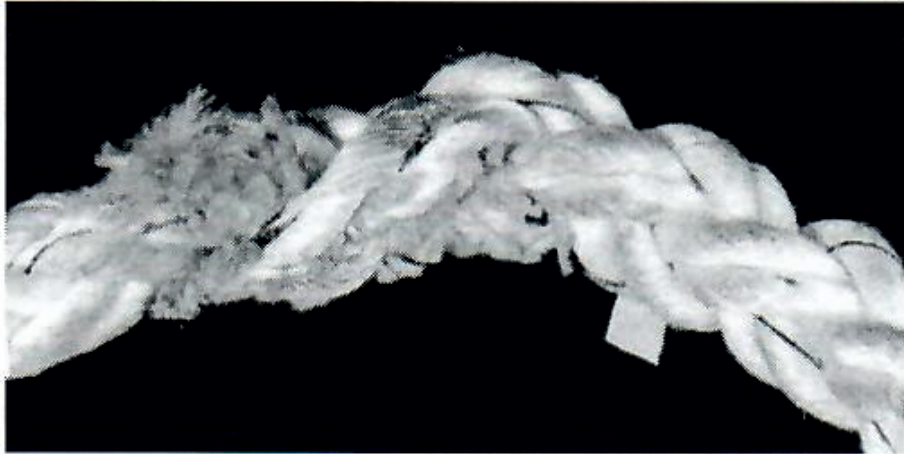
It is obvious during visual inspection to see where fibers have been cut sufficiently to degrade a rope. Damage assessment includes an evaluation of the amount of affected fiber, and location and orientation of the cut. For multiple cuts, the space between damaged areas is important.

Figure no. 8: **Localized external abrasion**

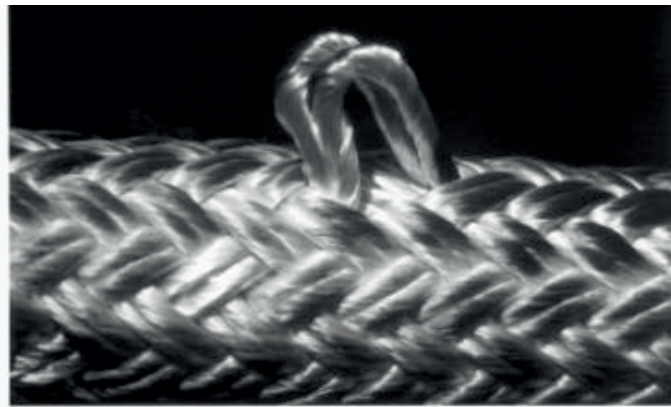
Strands and rope yarns can be snagged and pulled out of the rope structure (see Figures no. 9 and 10). The level of damage is a function of the percentage of the rope cross section that has been lost.

Figure no. 9: **Localized external abrasion 1**

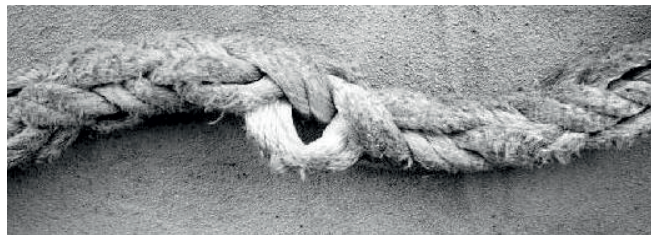
Figure no. 10: **Localized external abrasion 2**

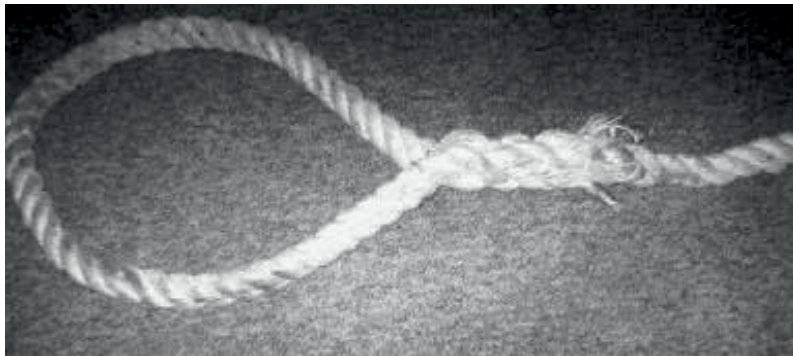
Damage is common at splices – see Figures no.11. This area always needs to be examined closely. Look for broken strands at the leg junction (see Figure no.11 c)), surface wear in the back (apex) of the eye, flattening where the rope bears on pins or bollards, slippage of tucks in stranded or twisted ropes and displacement of core/cover for braided rope with buried splices.

Figure no. 11 a): **damage of splicing - 3-strand splice of poor quality**

Tucks in 3, 8 and 12-strand and tucks in tuck splices in single braided may have slipped in the splice. The buried leg in single and double ropes may have slipped. Freshly exposed fiber in tucks or buried legs will look clean or have a slightly different appearance where it has pulled out of the body of the rope. See Figure no. 11 a), an example of a poorly made splice.

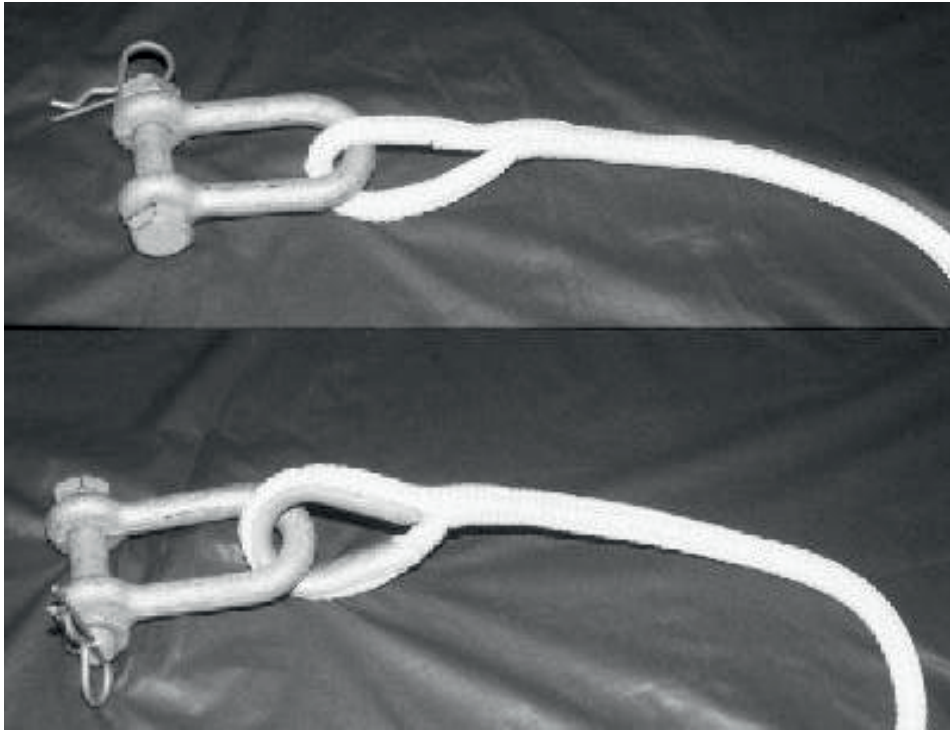
- In some cases, a thimble should be used but is not and excessive wear has occurred in the back of the eye. Figure no. 12 (upper), shows the rope eye directly on a shackle without a thimble. The rope is bent over about the same diameter as the rope itself ( $D/d$  ratio is lower than 15). This can give adequate strength when the rope is new or for very few loadings, but wear can be rapid in severe applications. Figure no. 12 (lower), shows a wire rope thimble in the same application.

Figure no. 12: **Rope with thimble (lower) and without (upper)**

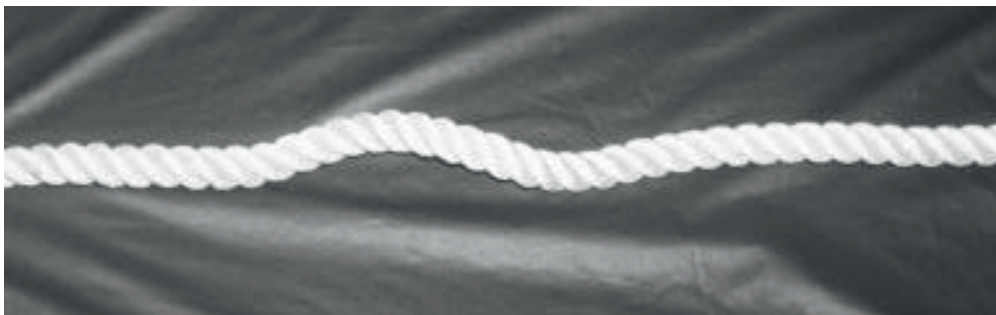
Braided and plaited ropes should display little or no twist, and those that do must not be used unless restored to normal appearance (see Figure no. 13).

Figure no. 13: **Corkscrew due to twist and Twist in 12-strand braid rope**

Induced twist may reduce a mooring line's strength. Removing Twist - see to Line maintenance guideline.

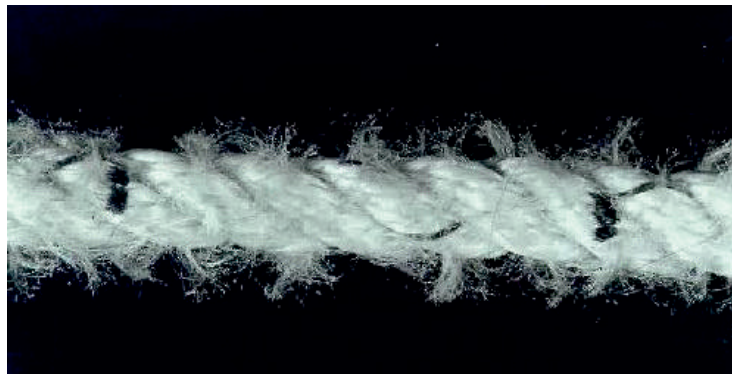
UV radiation from direct sunlight will cause brittle and weak outer rope yarns. UV degradation is difficult to inspect visually. Discoloration and brittleness in the filaments may be observed in some cases. Strength testing of a few surface fibers or the entire rope is required for a definitive assessment (see Figure no.14).

Figure no. 14: **UV degradation of PP rope**

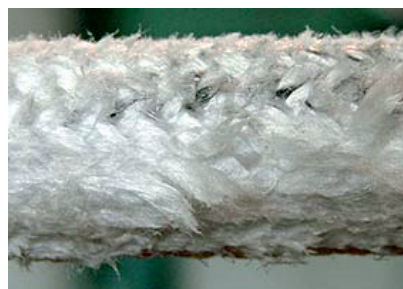
Synthetic fiber materials generally resist chemical attack and heat exposure in normal circumstances but can be weakened in certain situations. Visual inspection may reveal discoloration and brittleness of the fibers. Melting, bonding of fibers (see Figure no. 15) hardening or stickiness may be observed. However, these manifestation are not always present. The inspector should research the exposure history of the rope.

Figure no. 15: **Melting of fibers**
